Manhole Inspection Summary

Manhole # S33E__048MH

Insp Date: **8/5/08 12:25 PM**

Location Address: **120 w fayette st**

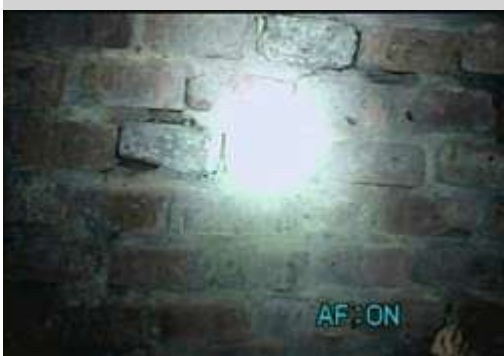
Defect 2

Condition: ☐ Sound ☐ Cracked ☐ Root Intrusion ☒ **Loose Brick** ☐ Deteriorated

loose bricks in barrel

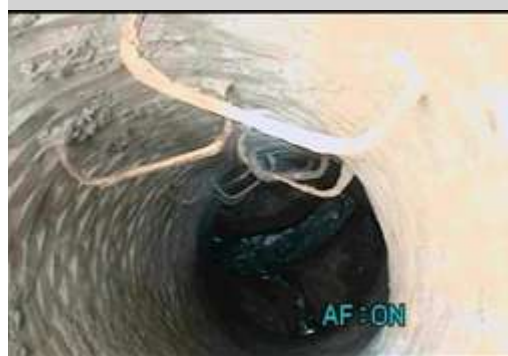
Defect 1

Count: **10** Missing: **3** ☒ **Corroded**

corroded/missing steps

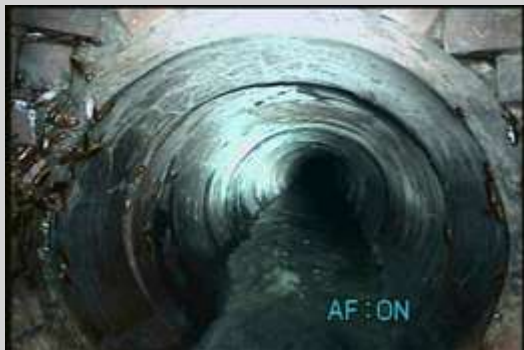
12 O'Clock Outflow

18 in. Circular Gravity Sewer
Pipe Out @ 12 O'Clock

Invert Depth: **16.00** (ft.) Flow Characteristics: **Fast**

Infiltration: **None** Pipe Seal Cond: **Unknown**

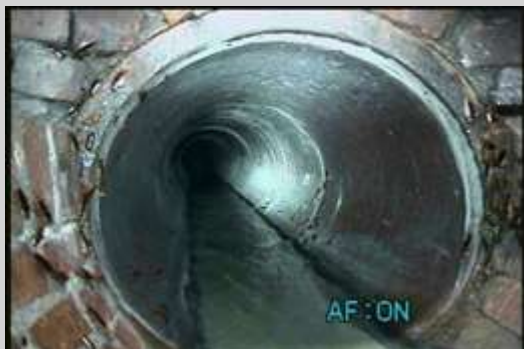
5 O'Clock Inflow

18 in. Circular Gravity Sewer
Pipe In @ 5 O'Clock

Invert Depth: **15.92** (ft.) Flow Characteristics: **Fast**

Infiltration: **None** Pipe Seal Cond: **Unknown**

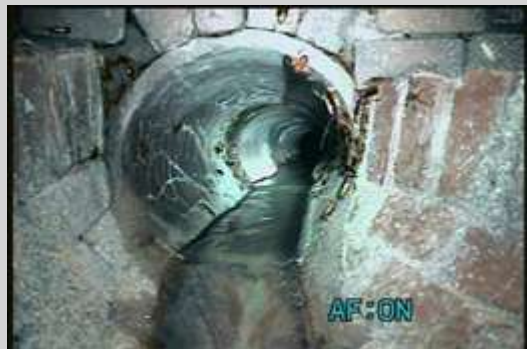
9 O'Clock Inflow

10 in. Circular Gravity Sewer
Pipe In @ 9 O'Clock

Invert Depth: **15.75** (ft.) Flow Characteristics: **Slow**

Infiltration: **None** Pipe Seal Cond: **Unknown**
